Severn Sound

Environmental Association

Citizen Science in Severn Sound: 2020 Data Report

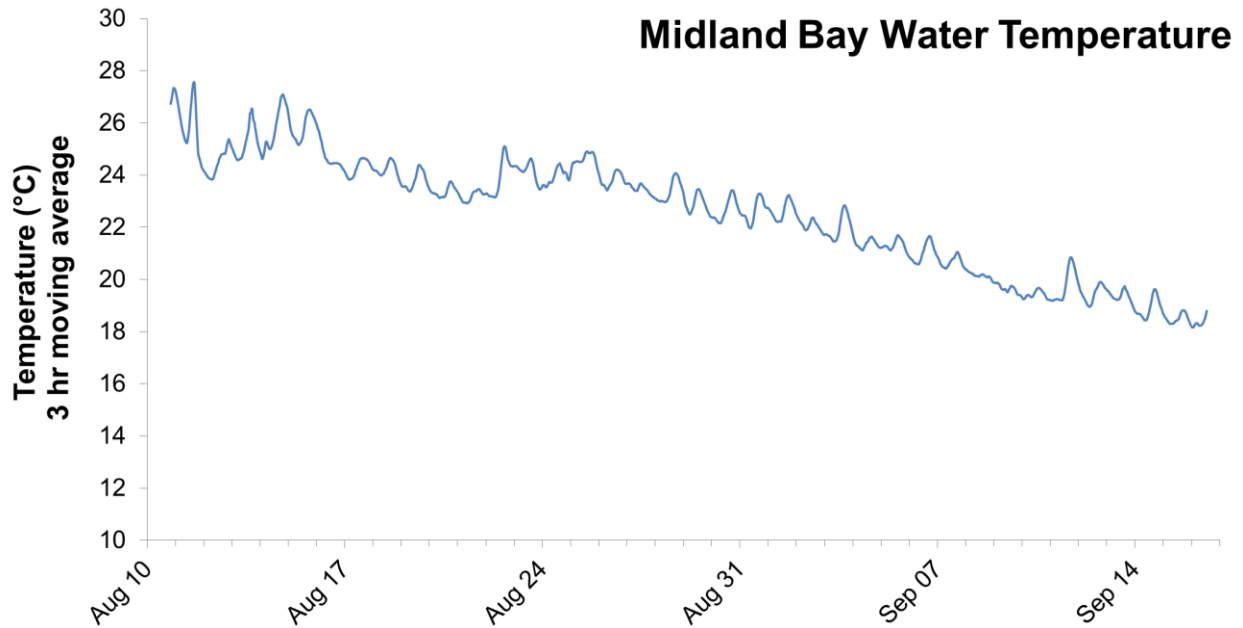
Temperature Logger Stats:
August 10 - September 16, 2020

Overall Minimum	18.1
Overall Average	22.5
Overall Maximum	27.8
Minimum Daily Range	0.5
Average Daily Range	1.4
Maximum Daily Range	4.0
Aug 10-31 Avg	24.1
Sept 1-16 Avg	20.3

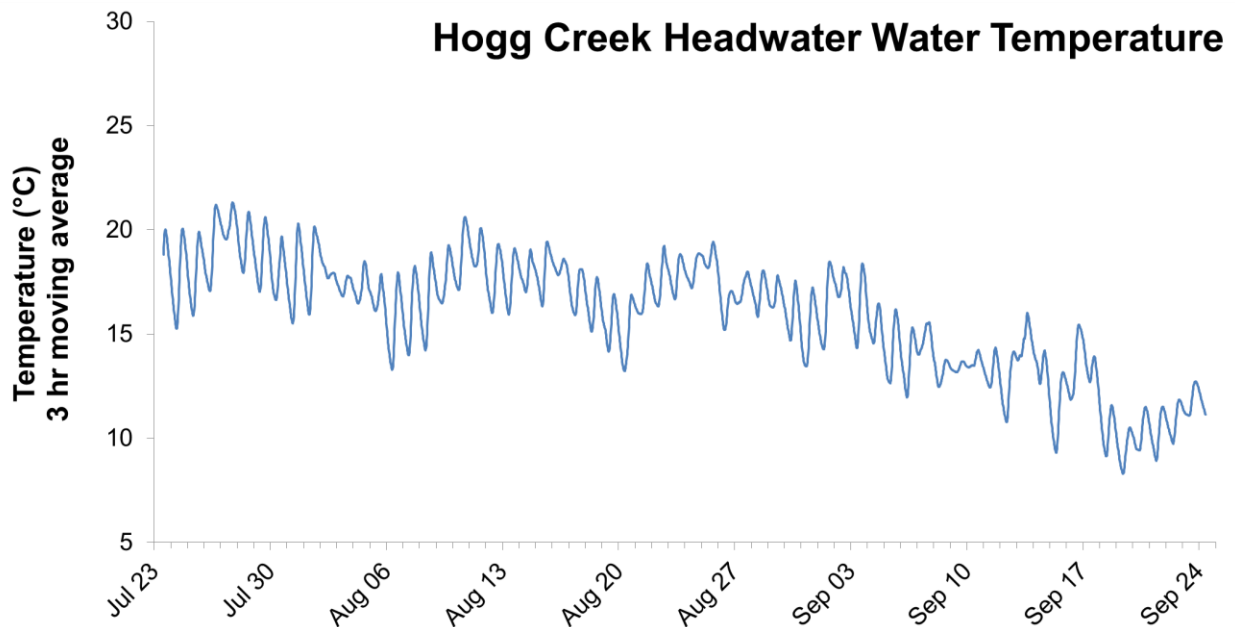
Hogg Creek Headwaters
Temperature Logger Stats:
July 23 - September 24, 2020

Overall Minimum	8.7
Overall Average	18.6
Overall Maximum	26.6
Minimum Daily Range	0.9
Average Daily Range	4.8
Maximum Daily Range	8.1
July 23-31 Avg	23.0
Aug Avg	20.2
Sept 1-24 Avg	15.1

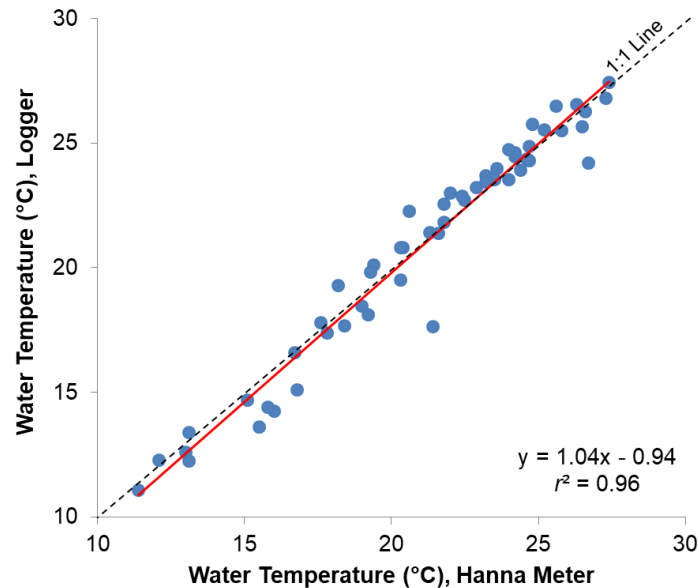
Figure 5. Temperature measured using a Hanna meter versus using a temperature logger.

Comparisons were made between temperature logger data and data from Hanna meters for five participants that had both loggers and meters. The data correlated very closely, indicating that the Hanna meters provided reliable temperature data (Figure 5).

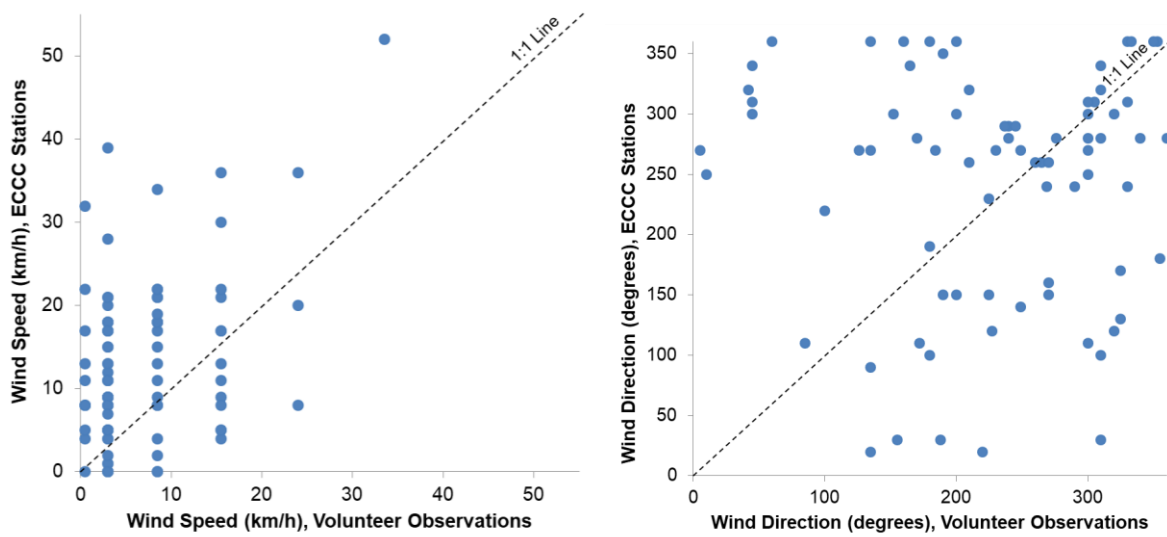
Figure 6. Wind speed (left) and wind direction (right) measured by volunteers versus measurements at ECCC stations. A 1:1 line (black dashed) is shown to aid comparison.

Wind data is very difficult to validate since it varies so much from place to place, and reliable sources of wind data are relatively far from the Severn Sound area. Depending on the location, volunteer data was compared to hourly wind data from one of three ECCC weather stations: Lake Simcoe Airport, Western Islands, and Muskoka Airport. Volunteers used the Beaufort Wind Scale, which uses observations of waves and movement of trees and loose objects to estimate wind speed, along with a weather vane and compass to estimate wind direction. This method introduces additional variability, as does the location of measurement (sheltered vs exposed) and whether winds were gusty or steady. Comparisons show that volunteers tended to underestimate wind speeds, and that wind direction was often not comparable between volunteer locations and ECCC weather stations (Figure 6).
