# Low Impact Development Obstacles, Concerns, Solutions, and Project Examples

*SCS Consulting Group Ltd.*

*May 2019*

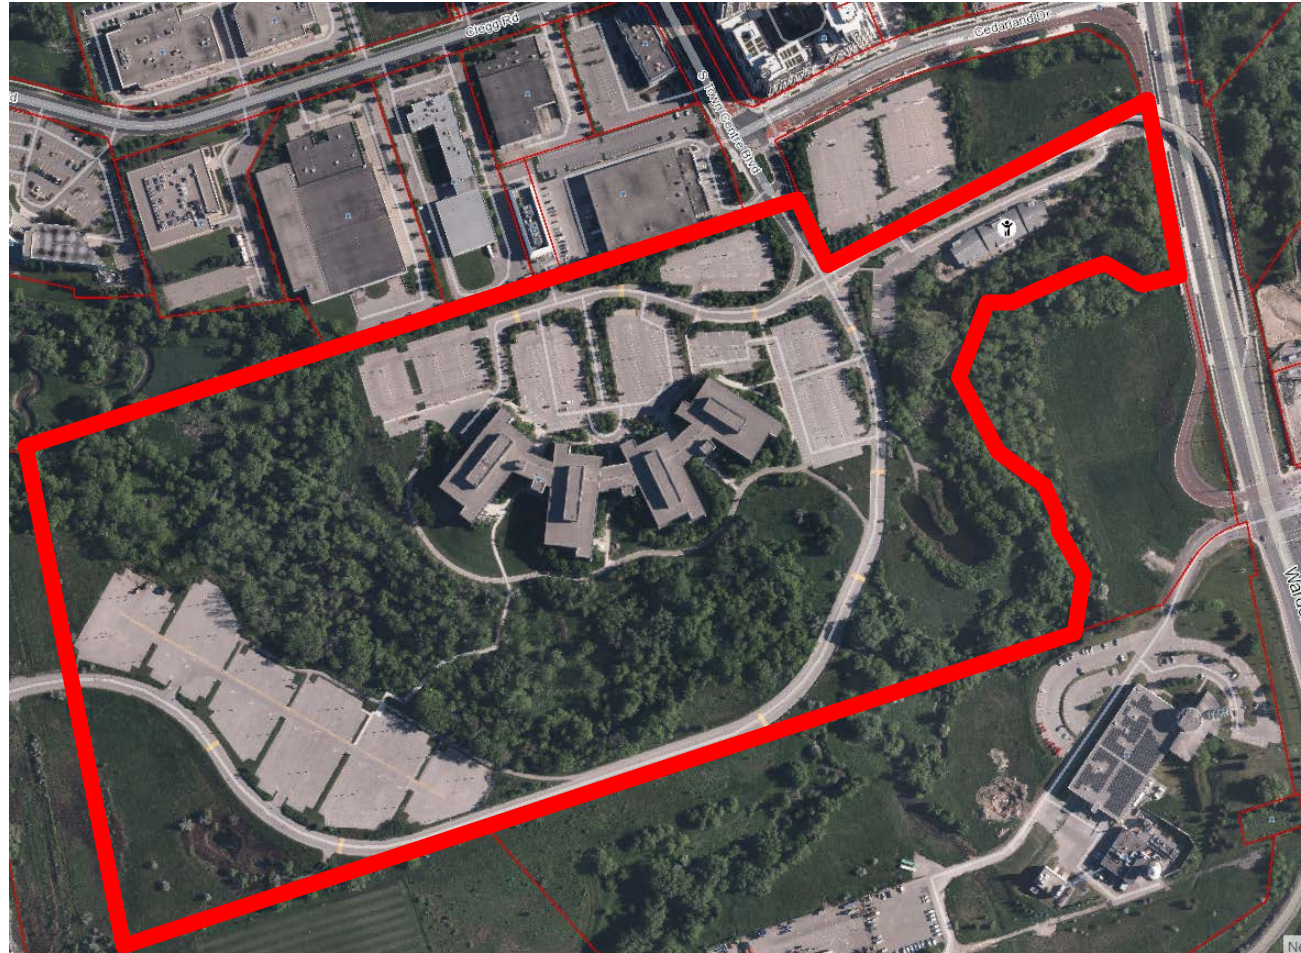
**IBM Facility for Software Development, City of Markham, TRCA**

- Property is 31.45 ha
- Consists of four (4) large office buildings
- Private road with multiple parking facilities
- Water quantity control – 2 through 100 year storms
- Water quality protection
- Water balance through infiltration

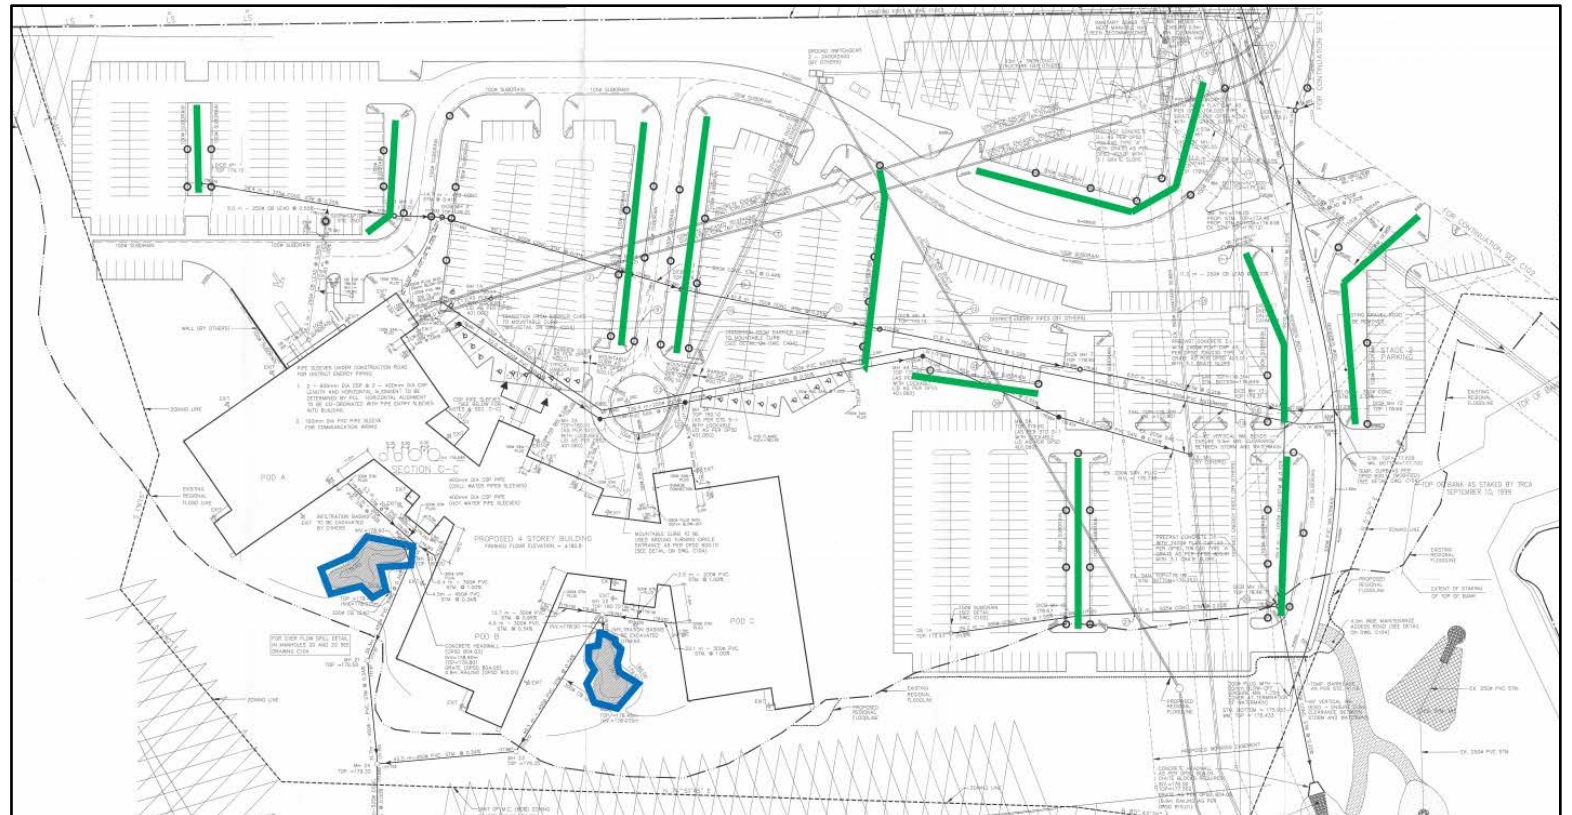
## IBM Facility for Software Development, City of Markham, TRCA

Parking Lot  
Bioswale

End-of-pipe Wet  
Quality/Erosion  
Pond

Infiltration Gallery  
for Rooftop  
Drainage

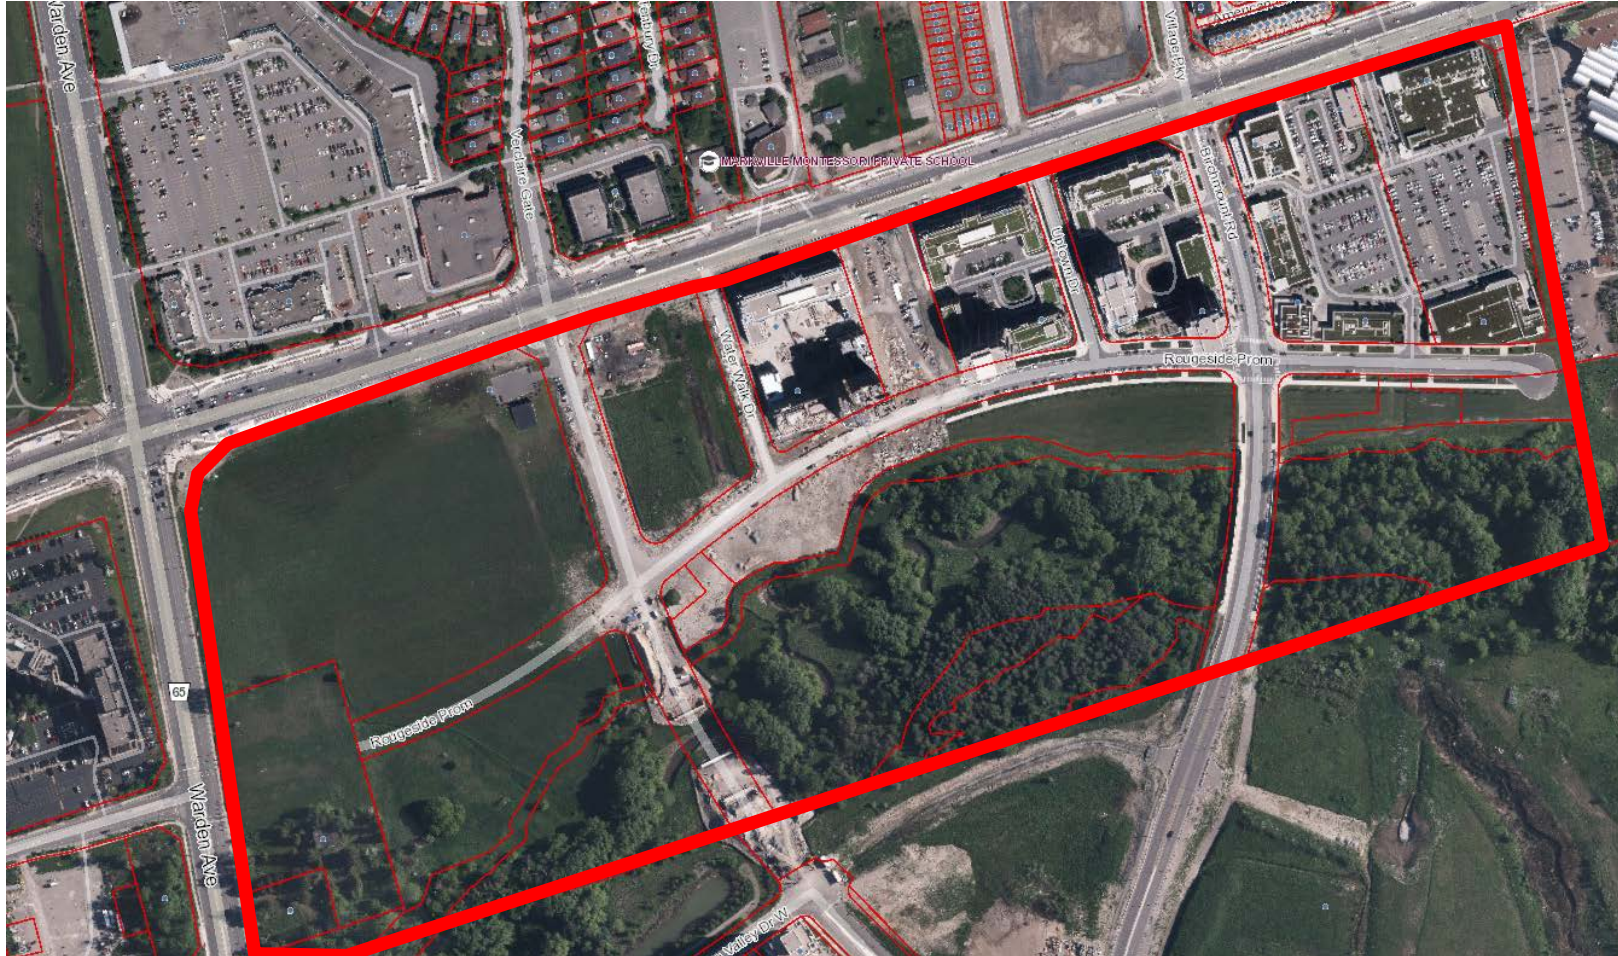
## Times Group Corporation, City of Markham, TRCA

- Property is 35.76 ha
- Consists of high density residential development with commercial block
- Condominium blocks with private roads, and municipal roads surrounding
- No Quantity Control – Drains directly to Rouge River
- Quality Control – 80% TSS Removal
- Erosion Control – 25 mm rainfall
- Water Budget
- LEED Certified
- Cooling of Stormwater Runoff  
(Redside Dace)
- 100% Park Credit

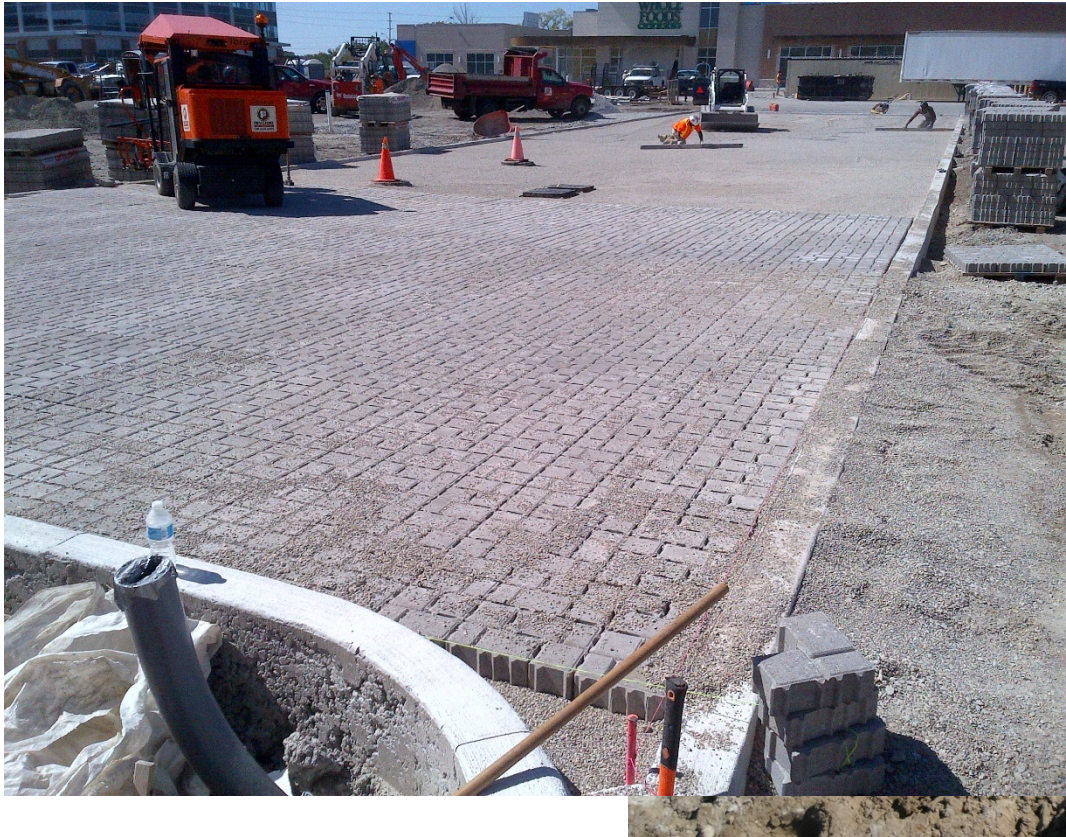
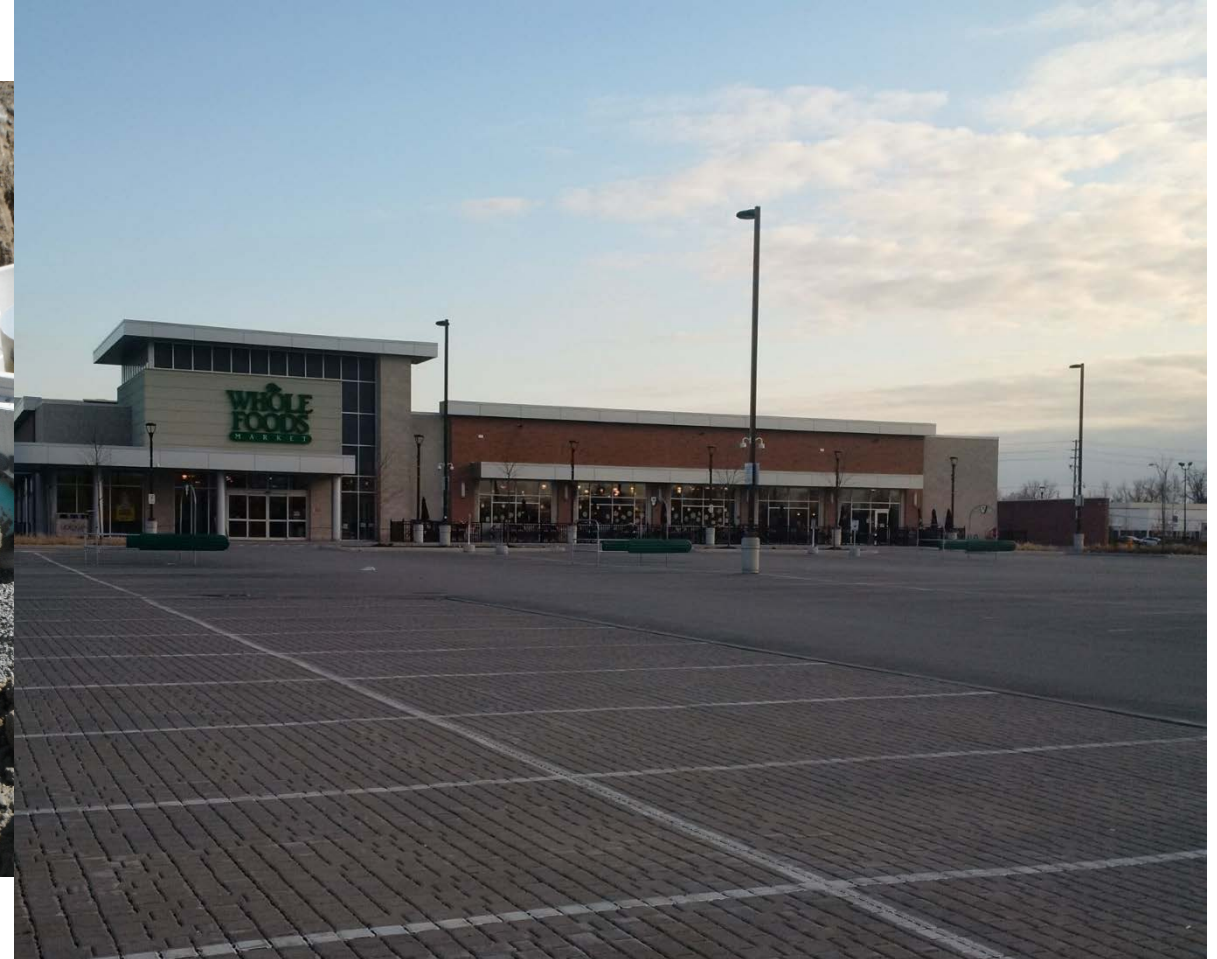
## Times Group Corporation, City of Markham, TRCA

Greens Roofs – 75% Building Coverage

Rooftop storage and evaporation of first 5mm of rainfall (standard roofs)

Rainwater Harvesting and Storage (Cisterns in Underground Parking)

Rain Gardens within Private Spaces

Pervious Pavement & Landscape Strip (2m private ownership)

Cisterns within Community Parks for Irrigation/Markham District Energy Cooling Towers – 100% park credit

Rain Gardens in Public Spaces

Pervious Pavement for Parking Lanes & Hard Surfaces in Park Blocks

Infiltration Galleries along the Valley Edge within Park Blocks – 100% park credit

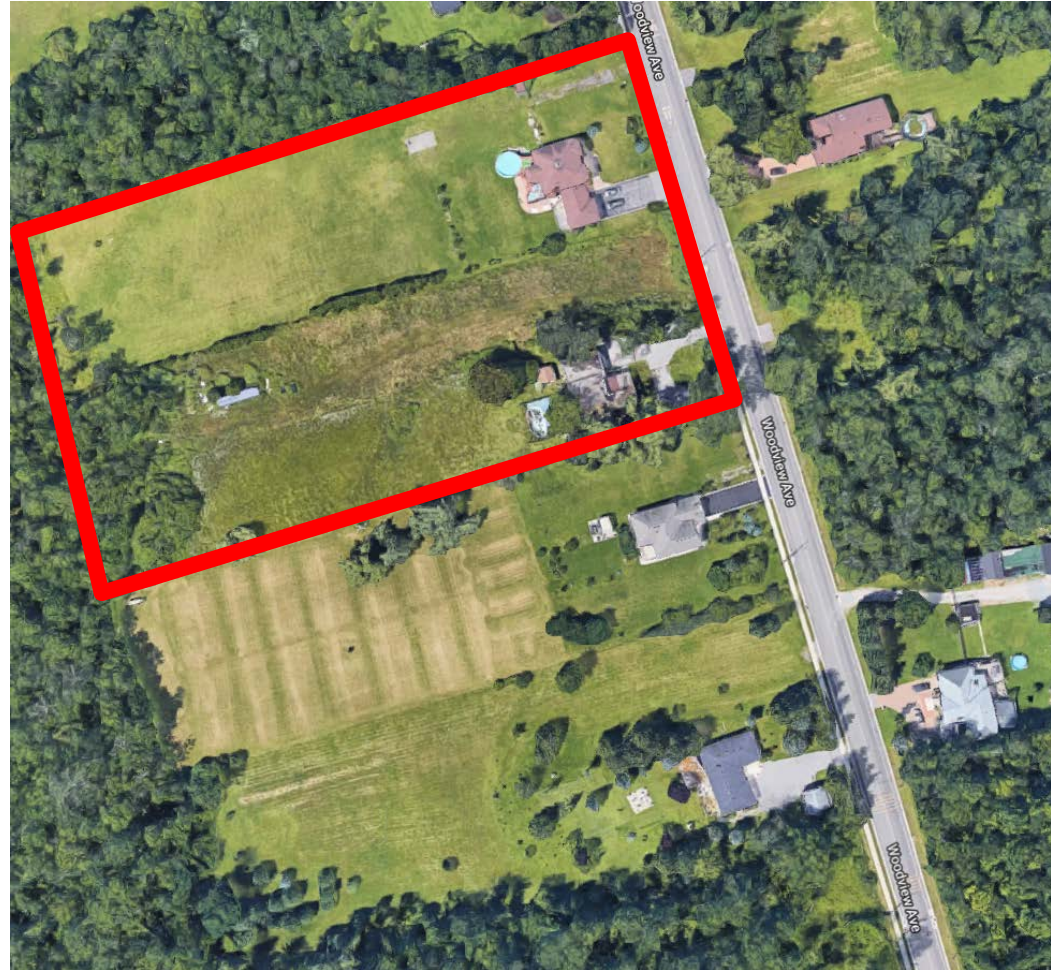
**Woodview Avenue, City of Pickering, TRCA**

- Property is 2.02 ha
- Consists of low and medium density residential
- Public roads
- Water quantity control – 2 through 100 year
- Water quality – 80% TSS
- Water balance through infiltration
- Provincially Significant Wetland

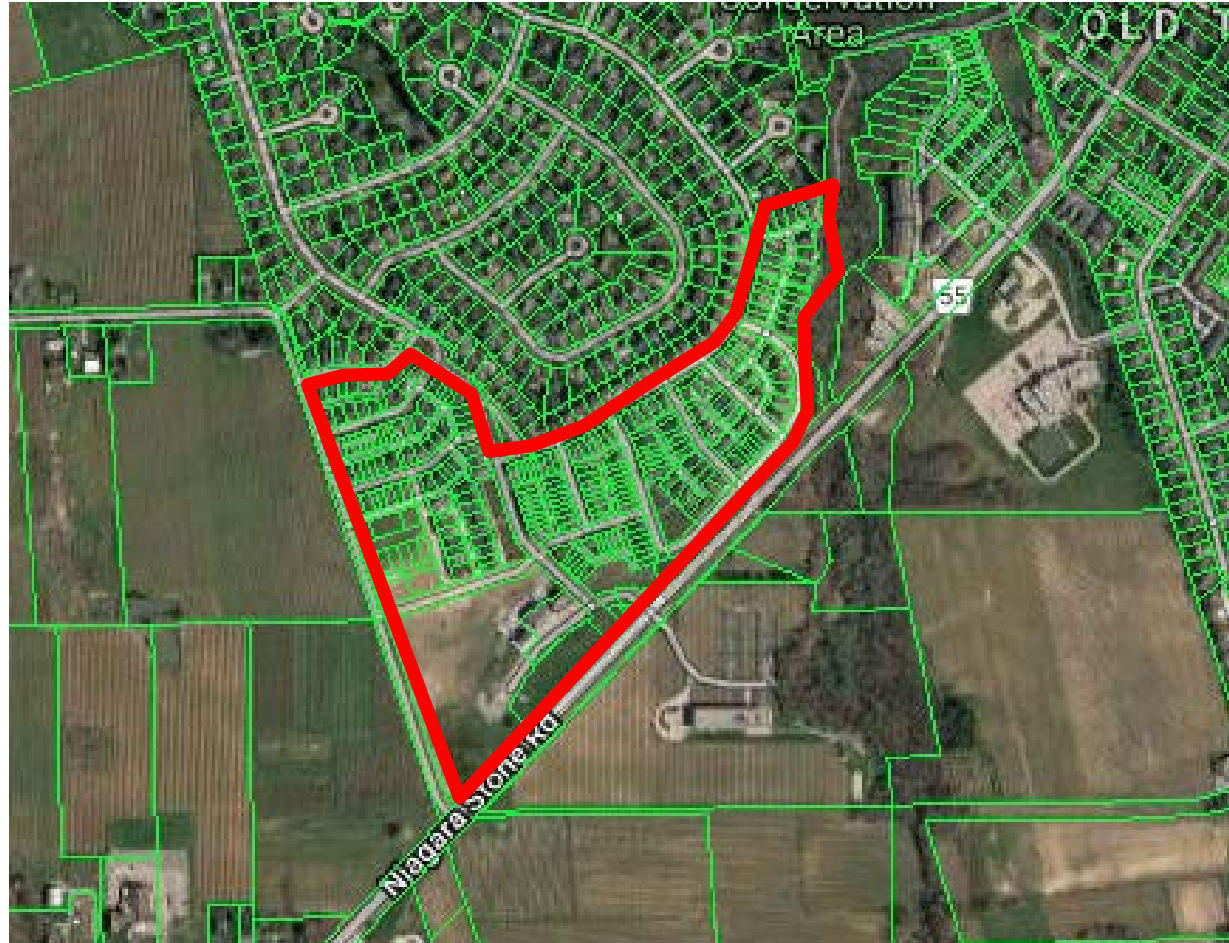
**Brookfield Residential, Niagara-on-the-Lake, NPCA**

- Property is 16.04 ha
- Consists of low and medium residential development and commercial
- Public road
- Water quantity control – 2-100 year control
- Water quality – 80% TSS
- Water balance through infiltration
- 100% Park Credit
