## PENETANGUISHENE REMEDIATION PROJECT

### Report on Wood Pile Removal Phase

March 1996

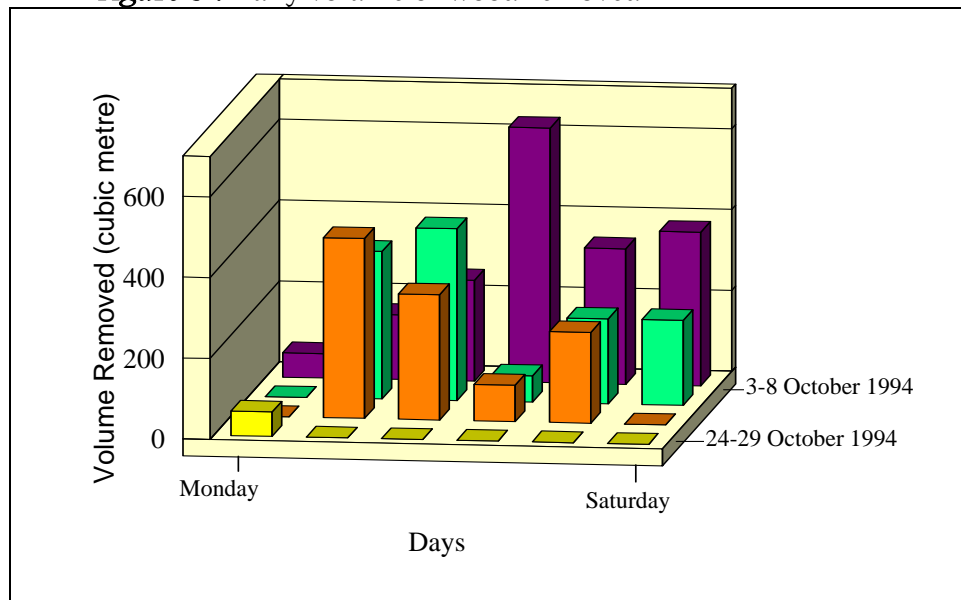
**Figure 5 : Daily volume of wood removed**

Figure 5 presents the daily volume of wood removed during the entire project. This figure indicates that the maximum volume of wood removed in one day was 630 m<sup>3</sup>, while the minimum was 0 m<sup>3</sup>. The daily average was approximately 300 m<sup>3</sup>. Zero cubic metre volume removed was due to statutory holiday (Thanksgiving, Monday, 10 October 1994), use of dragline (Monday, 17 October 1994) and the fact that no removal work was performed on that day (Saturday, 22 October 1994, Tuesday, 25 October 1994 to Friday, 28 October 1994).

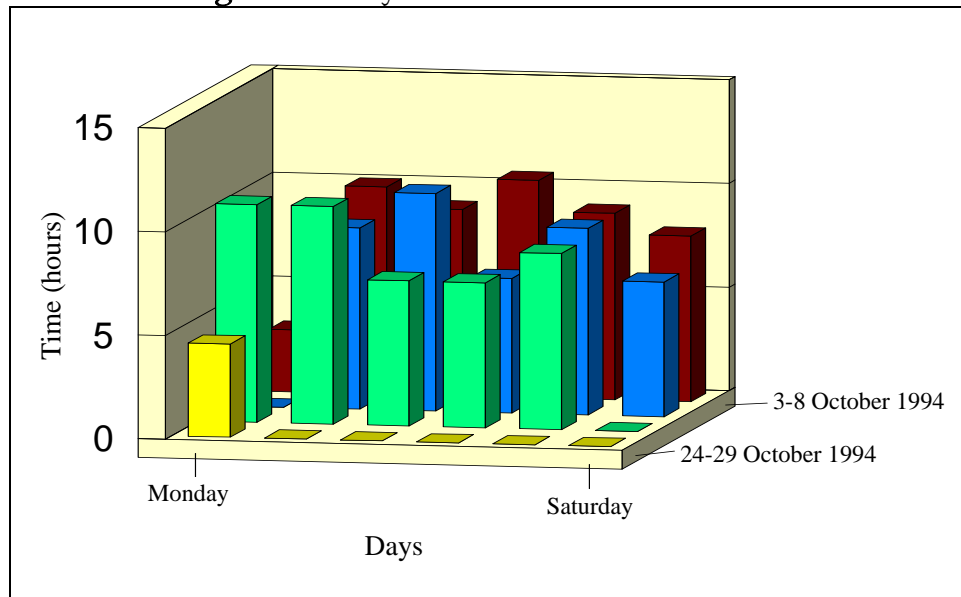
**Figure 6 : Daily time devoted to wood removal**

Figure 6 shows the daily time devoted to the removal of the above noted volume. It can be seen that the longest days lasted 10.5 hours, but averaged 9 hours.

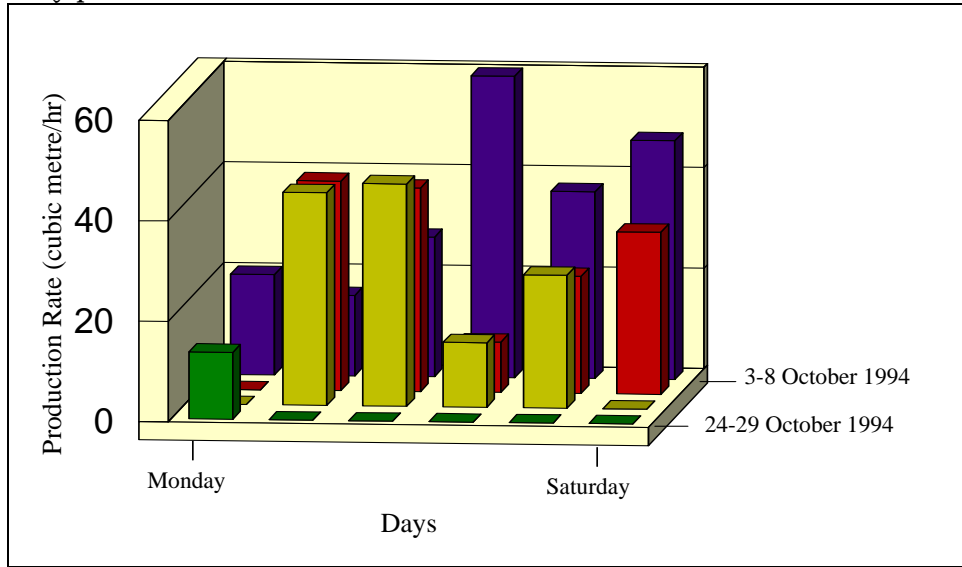
Figure 7 : Daily production rate

From those two figures, daily production rate was calculated and Figure 7 was produced. This figure indicates that the daily maximum production rate achieved was 60 m<sup>3</sup>/hr, with an average of approximately 30 m<sup>3</sup>/hr. Downtimes happened on:

A total of 139.25 hours were required to remove 3,970 m<sup>3</sup> of wood wastes, of which 120.5 were devoted to the removal of 3,595 m<sup>3</sup> of larger wood wastes and 19 hours were devoted to the Visor Grab demonstration. This total duration leads to a dredging efficiency of over 90 %, with an average production rate during the removal of larger wood wastes of approximately 30 m<sup>3</sup>/hr. Cycle times fluctuated between 55 seconds to 1 minute and 30 seconds during removal of larger debris. The percentage of solids was estimated to be near 80 % during the large debris removal phase.

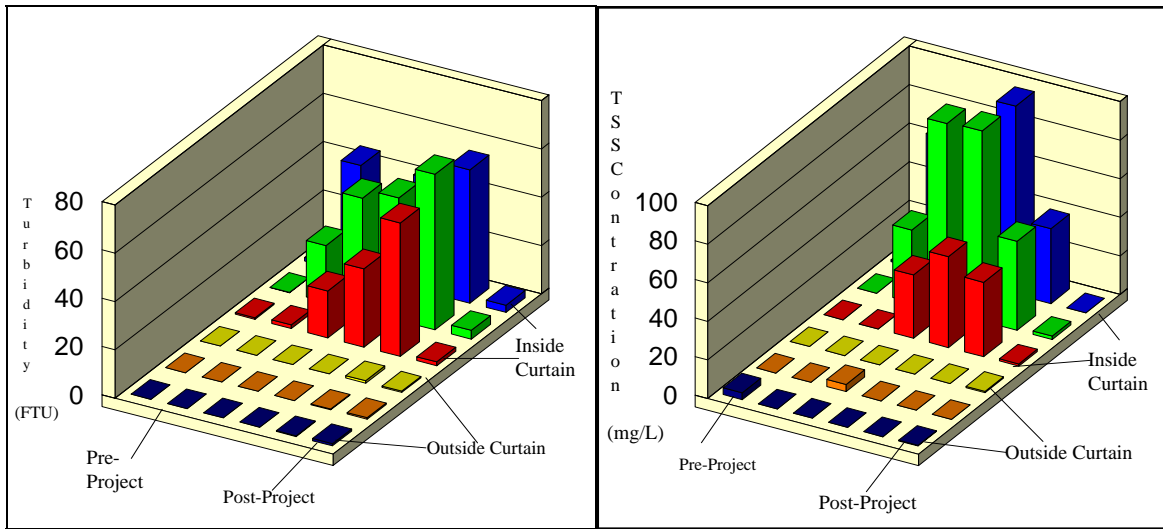
Figure 9 was produced using the turbidity results. These results indicate that the turbidity gradually increased in the confined area, which is related to the nature and the particle sizes of the dredged material. Sawdust and fine particles such as clay tend to re-suspend easily, and stay in this re-suspended state longer than large particles such as sand and gravel. An accumulation of easily re-suspended material occurred in the confined area throughout the duration of the project. These results also indicate that this re-suspended material took approximately one week to settle.

**Figure 9 : Turbidity less ambient levels**

**Figure 10 : TSS concentration less ambient levels**

The results from Figure 9 also indicate that very little material exited the confined area since the turbidity immediately outside the silt curtain is always comparable to the turbidity at mid-bay (ambient level). Figure 10 was also generated using the total suspended solids concentrations results. These numbers indicate the same trend as for those for turbidity.

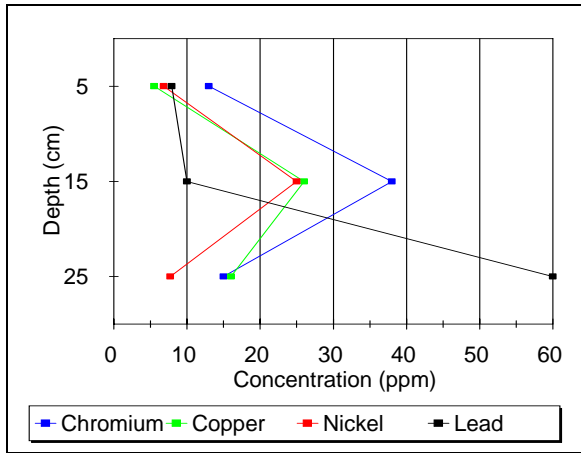
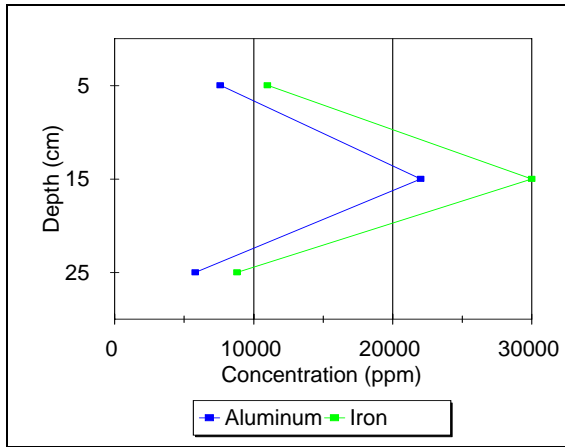
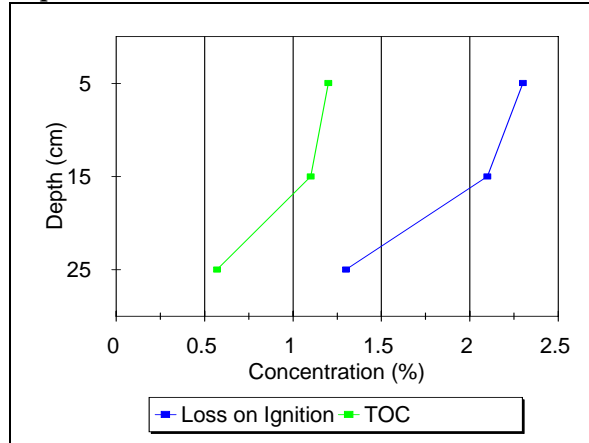
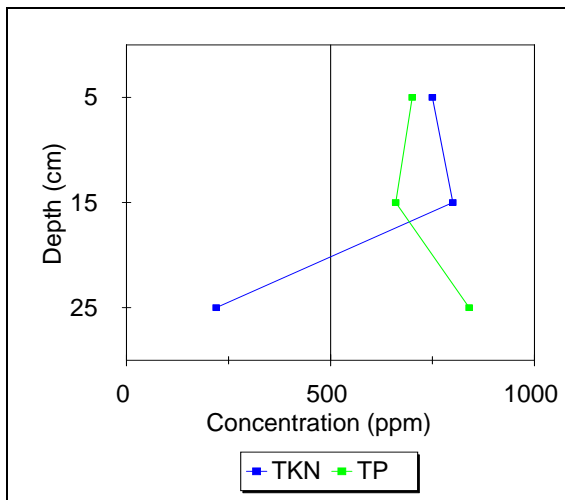
Figure 11 to 15 show the results for chemical analyses of sediment from core #1. These results indicate that the concentration of trace metals (Cu, Cr, Ni), aluminum and manganese greatly increase at a depth of 15 cm to levels above their OMOEE lowest effect level guideline, while heavy metals (Pb, As, Cd) except for mercury, have significant increases at 25 cm, again to levels above their OMOEE lowest effect level guideline. The concentration of organic indicators (TOC & LOI) and total Kjeldahl nitrogen significantly decreases with depth. The concentration of phosphorus tends to increase with depth. Although the concentration of most parameters tends to increase with depth, the results indicate that all chemical parameters for the newly exposed sediment are all below their respective OMOEE lowest effect level guideline.

Of most importance is the comparison of the results from Figure 11 to 15 with the concentration of surficial sediment for the entire harbour. Table 3 shows the maximum, the minimum and the mean concentrations of surficial sediment from samples taken between 1988 and 1990 (Krantzberg and Sherman, 1995). The comparison indicates that only the concentrations of aluminum, cadmium and total phosphorus are above the minimum concentration recorded in samples from the entire Penetang Bay.

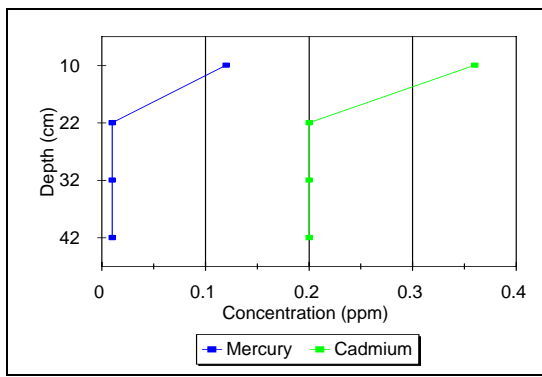
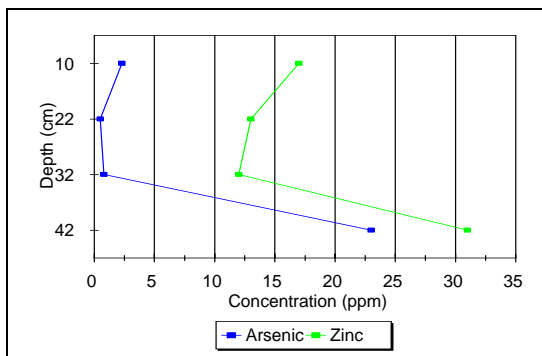
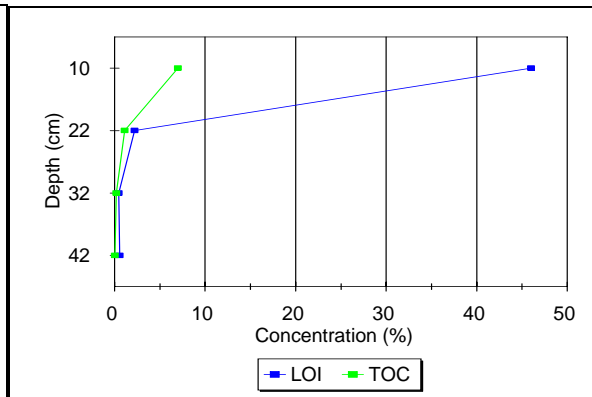
Figure 16 to 21 show the results of chemical analyses performed on the sediment from core sample # 2. The results indicate that the concentration of most trace metals (except for Fe) increase at a depth of 42 cm. Although this increase is significant, the final concentration is still lower than the OMOEE lowest effect level guideline. The concentration of heavy metals (except for arsenic) does not show any significant fluctuation with depth. The concentration of arsenic increases significantly at a depth of 42 cm to a level above the OMOEE lowest effect guideline of 6 ppm. The concentrations of organic indicators (LOI & TOC) and conventional parameters (TKN & TP) decreases with depth. The results also indicate that the surficial concentration of TKN (0-10 cm) is very close to the OMOEE severe effect guideline of 4,800 ppm (surficial concentration = 4,600 ppm).

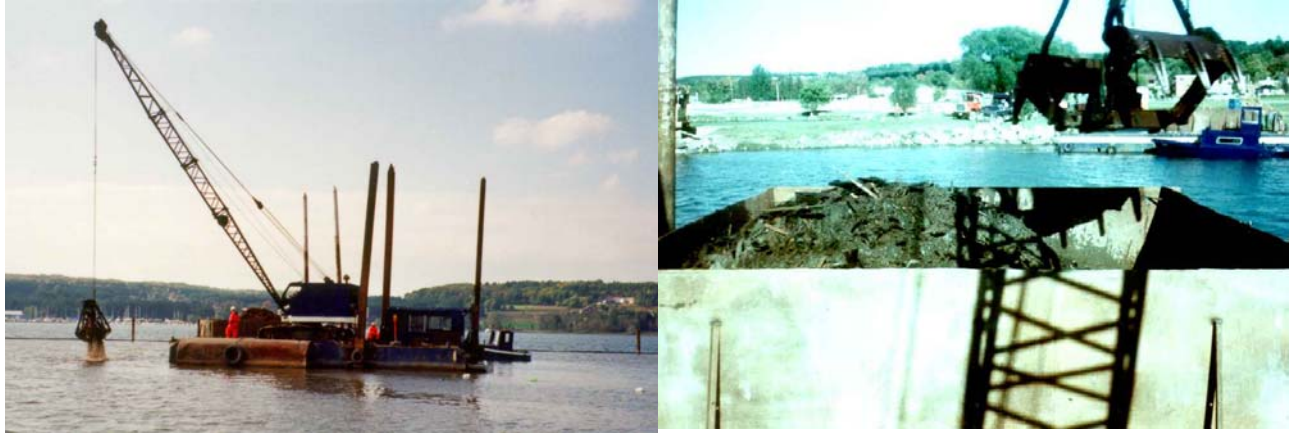
Picture 1: Grapple Fork full of wood debris

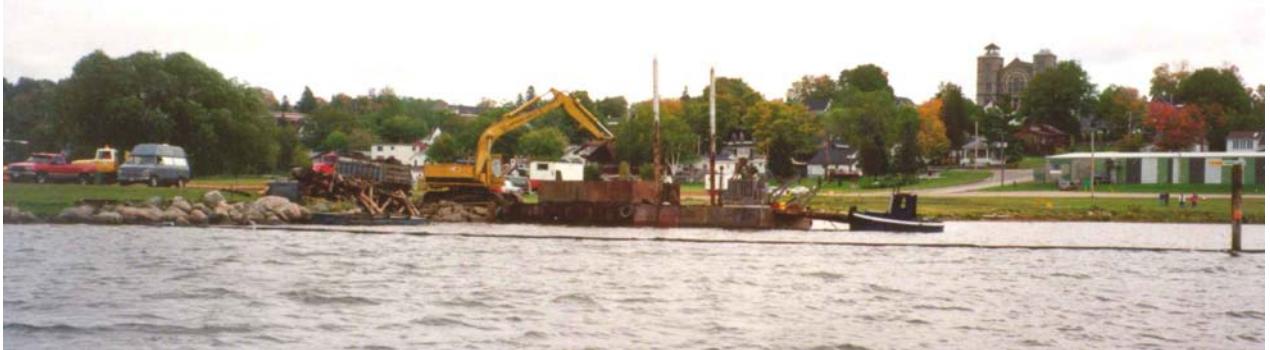
Picture 2: Offloading ramp. Excavator used to transfer wastes from barges to trucks

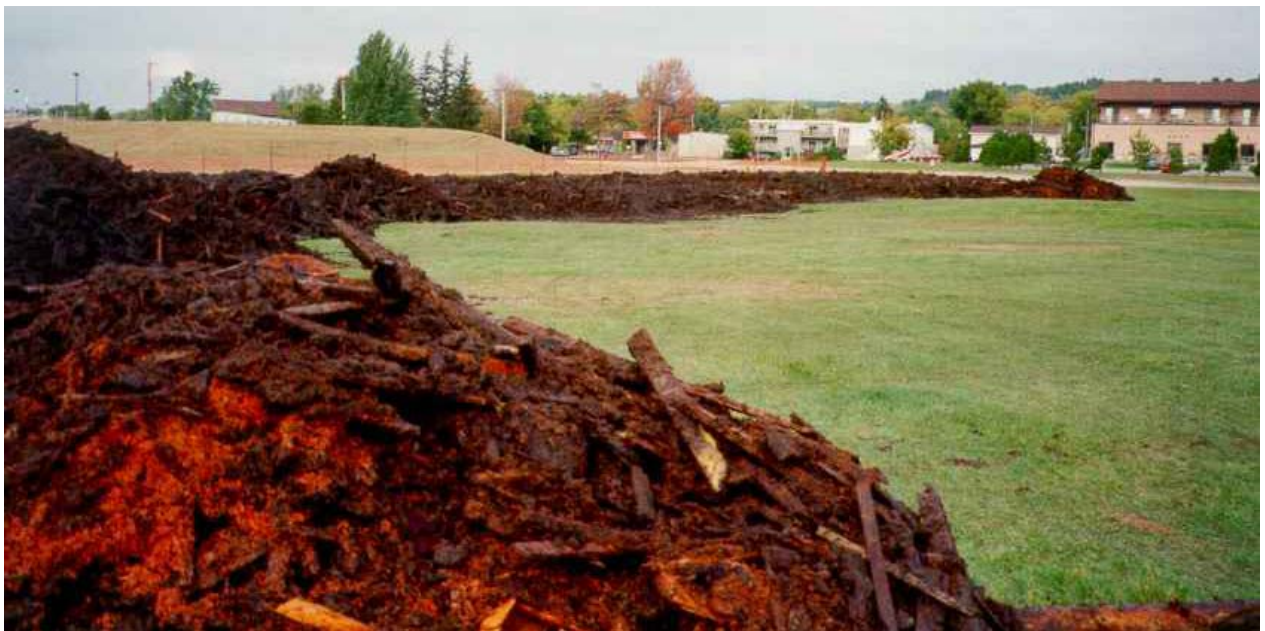
Picture 3: Temporary storage area. Material is composed of sawdust, wood slabs and logs

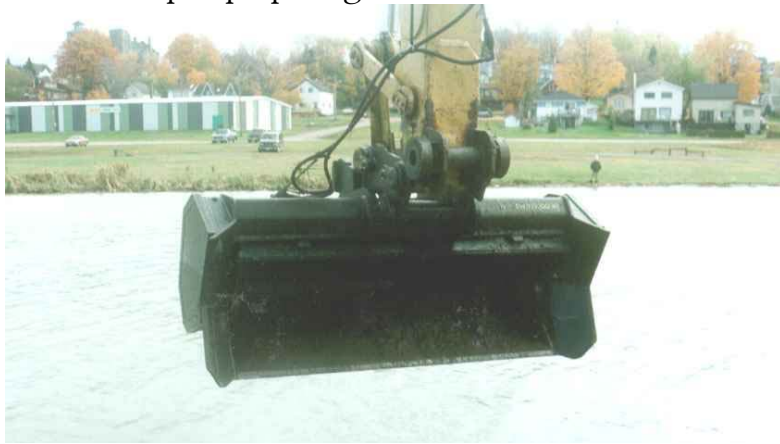
Picture 4: Visor Grab Bucket open preparing for descent

- A sensor indicating complete closure of the bucket should be installed on the Visor Grab. This sensor would indicate to the operator that the bucket is sealed and that minimal leaks or spills will occur during lifting.

- Hydraulic pressure guiding the visor closure should be increased. With increased hydraulic pressure, the visor would seal more tightly and small debris could be broken.

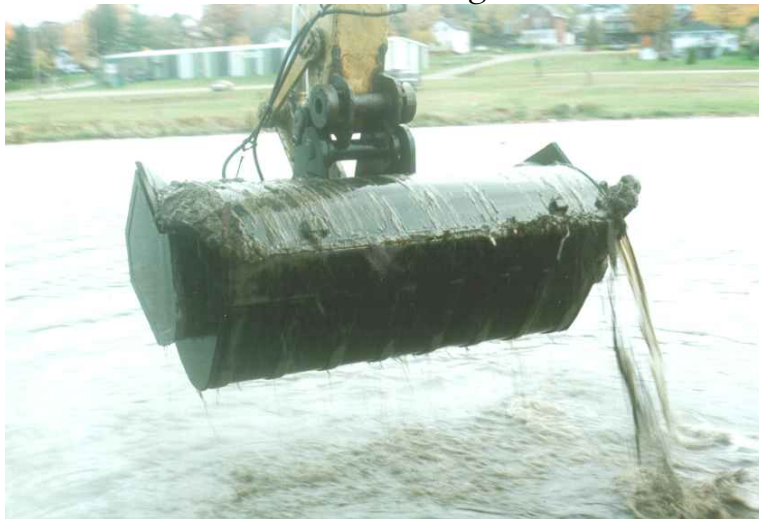
Picture 5: Visor Grab Bucket full with minimal leakage

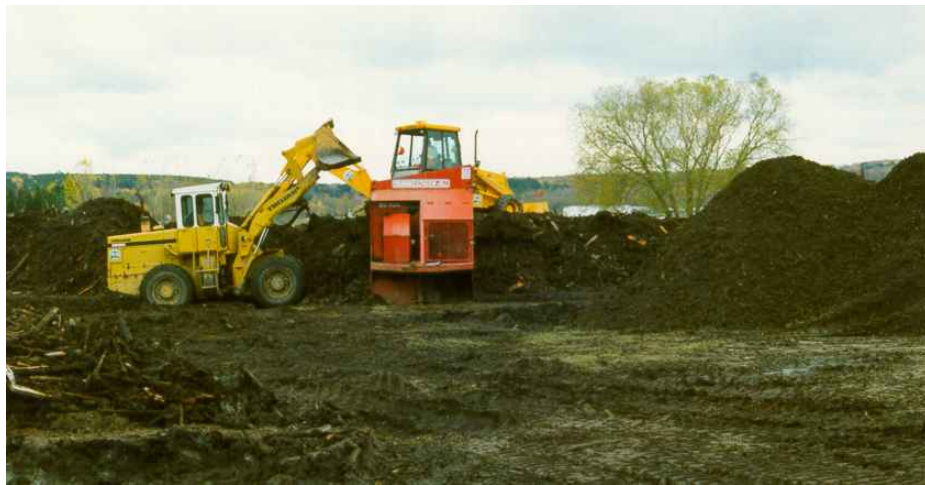
Picture 6: Mechanical screening of wastes by the Town of Penetanguishene
